## Test Report

Report No.: 13032Ra

**Test object:** Metal-enclosed, air-insulated switchgear in a two-panel arrangement  
**Designation:** ZS8.4, panel width 800 mm  
Rated voltage: 24 kV      Rated normal current: 1250 A      Rated frequency: 50 Hz  
**Manufacturer:** ABB s.r.o., Brno, Czech Republic  
under licence of ABB Technology Ltd., Zurich, Switzerland  
**Tested for:** ABB Technology Ltd., Zurich, Switzerland  
**Testing station:** PEHLA-Testing Laboratory Ratingen, Germany  
**Date of test:** 07<sup>th</sup> March 2013

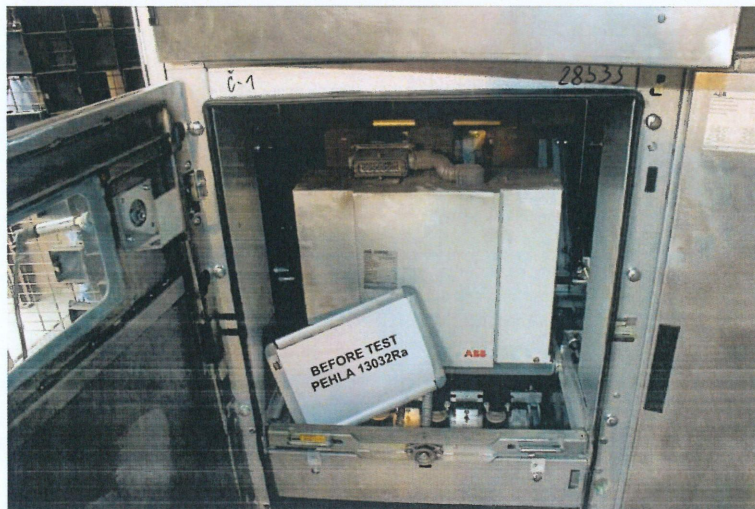
Photo No. 02  
Before test PEHLA 13032Ra / 03  
Test object, front view with doors of left-hand side panel opened.

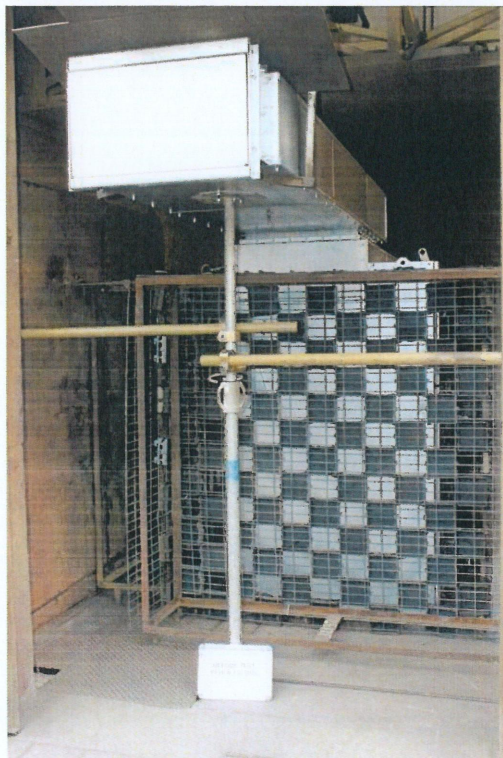
Photo No. 08  
Before test PEHLA 13032Ra / 03  
Test object, side view with indicators and closed hatch at the end of the outlet

The internally developing pressure of the test object was relieved by operation of a pressure relief flap via a pressure relief duct into the outer air outside the room mock-up. Lateral outlet with an internal cross section of 815 mm x 328 mm with a pressure relief device with preloaded opening at the end of the outlet.

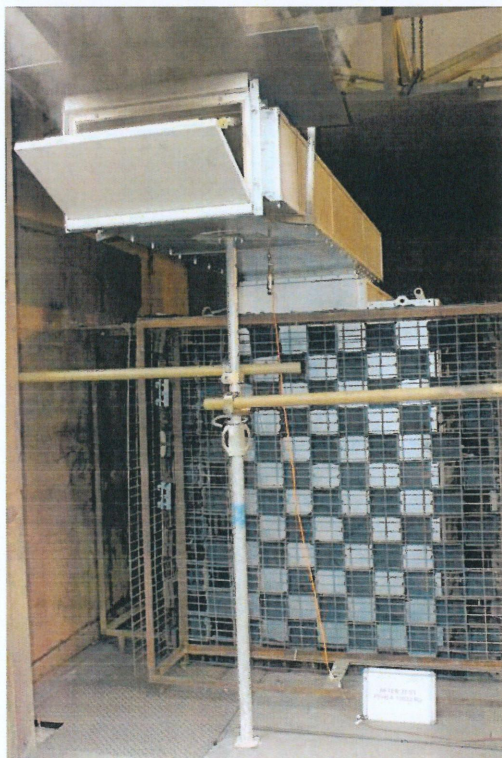
Photo No. 10  
After test PEHLA 13032Ra / 03  
Test object, side view with indicators and opened hatch at the end of the outlet

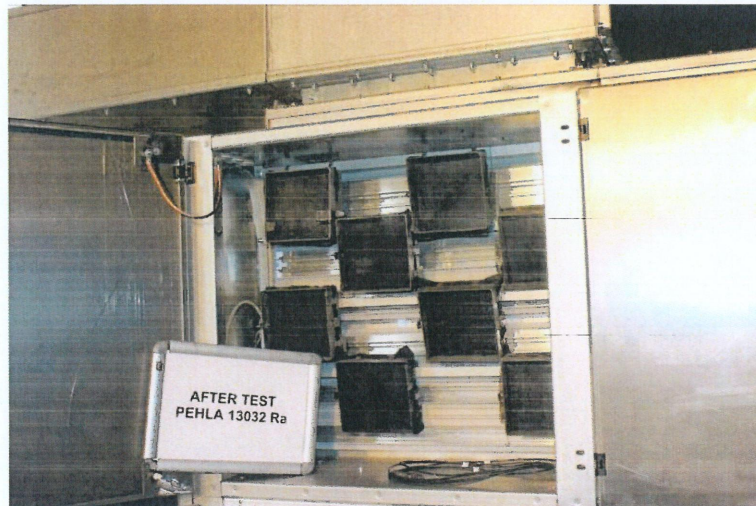
Photo No. 12  
After test PEHLA 13032Ra / 03  
Additional indicators within low-voltage compartment

The test object passed the test performed in accordance with the applied test specifications. The requirements for the verification of the internal arc classification IAC AFLR 25kA 1s are met for the compartment tested. The additional indicators placed within the low-voltage compartment did not ignite.
